Special Report 76-11

OBSERVATIONS
ALONG THE PIPELINE HAUL ROAD
BETWEEN
LIVENGOOD AND THE YUKON RIVER

R. Berg and N. Smith

October 1976

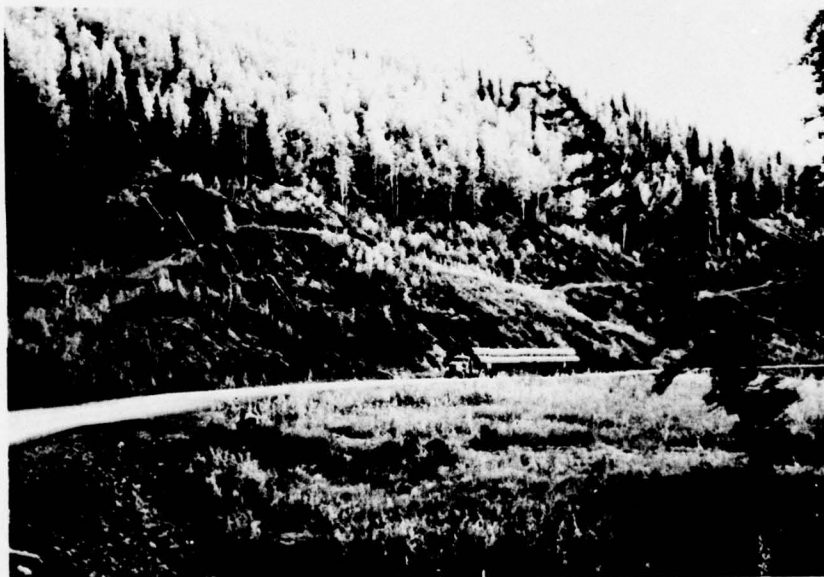
103. Overall view of backslope, Mile 33.3 Rt, 14 September 1975.

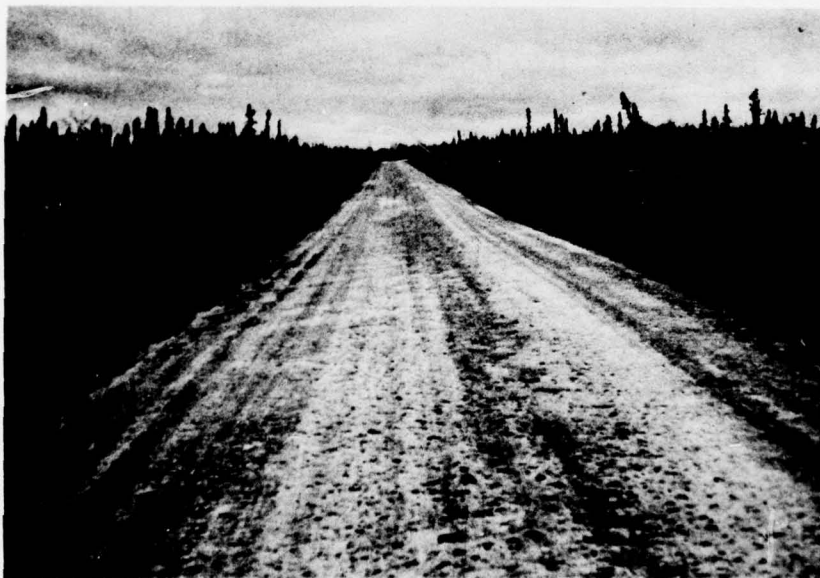
109. Centerline looking north, Mile 16.3, 30 May 1975.

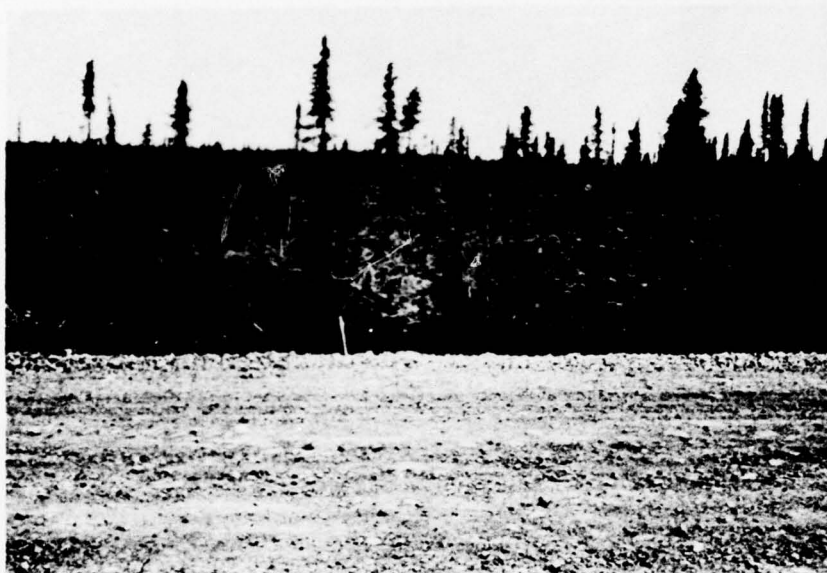
Figures 110 and 111 illustrate the conditions at the second cross-section site on 27 June 1970. This site is at station 2710+00 at about mile 50.7 (81.6 km). The finished grade elevation was 1177.5 ft (358.8 m) and the width of the roadway surface was about 28 ft (8.5 m). The section is located in a relatively flat area with very little vertical grade on the road which runs in a northwesterly direction. At this site the trees and vegetation had been disturbed for a width of only about 20 ft (6.1 m) beyond the toe of the slope on each side of the road. Figure 112 illustrates changes in cross-section levels for this section from 27 June 1970 through September 1975. The roadway centerline has subsided about 1.25 ft (0.38 m) since it was constructed. Reasons for the settlement can be inferred from exploratory borings for the pipeline in that vicinity (Fig. 113). The boring logs were taken from Alyeska (1971) and the locations were within 500 ft (150 m) of the cross-section site. Occasional to considerable amounts of visible ice were encountered in the top 3 to 6 ft (1 to 2 m) of overburden. This would easily account for the recorded settlements.

110. Left side of road, Mile 50.7, 27 June 1970.

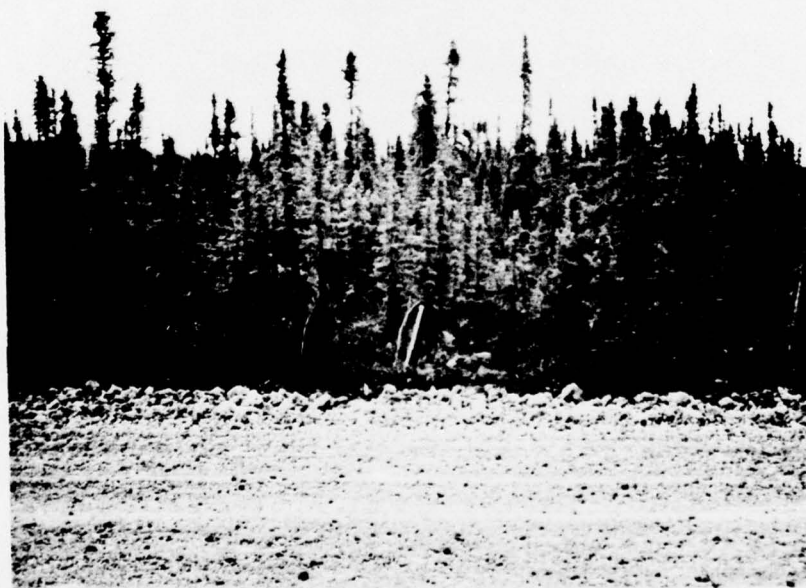
111. Right side of road, Mile 50.7, 27 June 1970.
